Installation of Existing Lift Systems for the Handicapped on Light Rail Vehicles

Prepared by
The Budd Company

May 1985
Final Report

1. Report No. UMTA-MA-06-0153-85-2		2. Government Accession No.		3. Recipient's Catalog No.	
4. Title and Subtitle INSTALLATION OF EXISTING LIFT SYSTEMS FOR THE HANDICAPPED ON LIGHT RAIL VEHICLES				5. Report Date May 1985

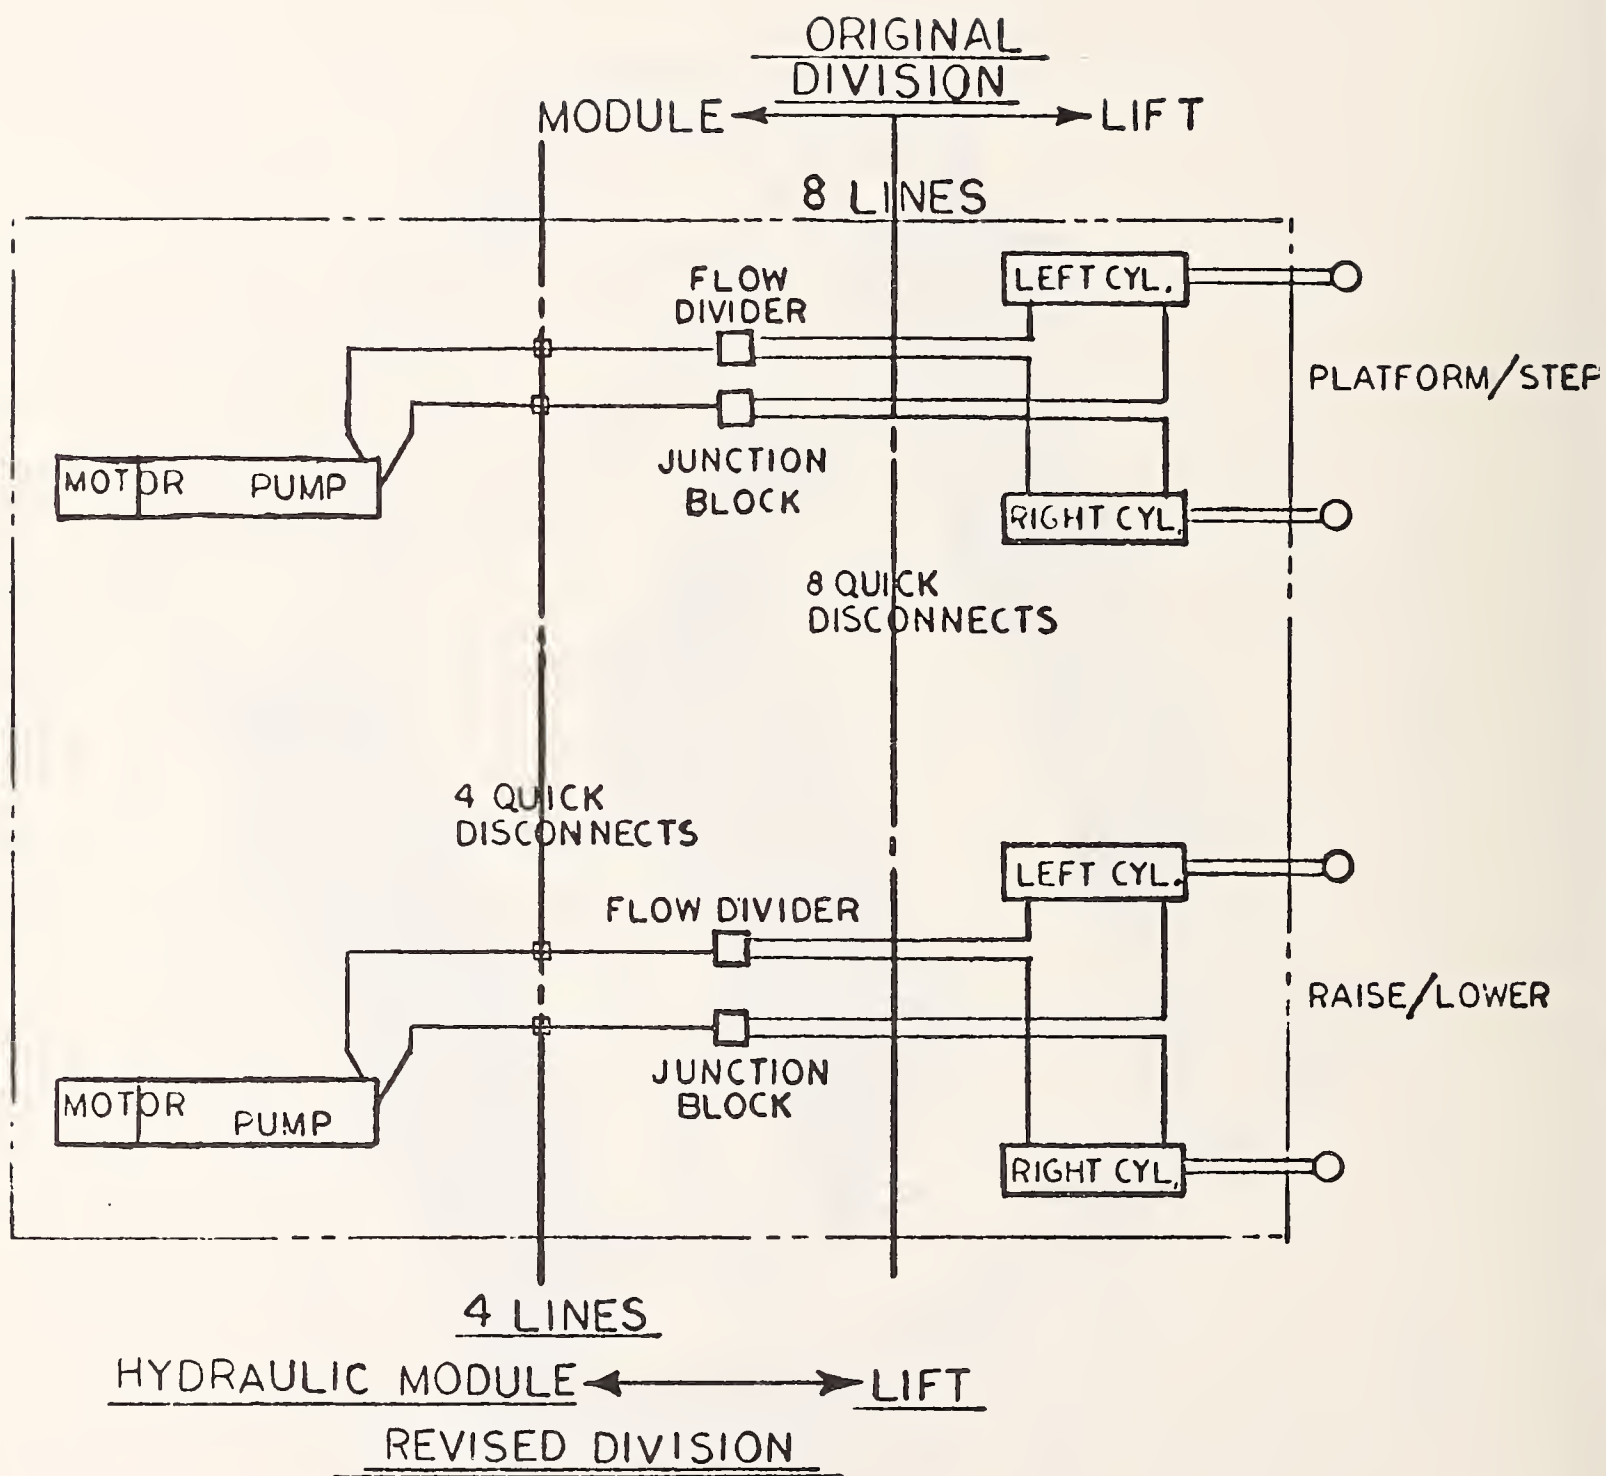
FIGURE 4-5. HYDRAULIC SCHEMATIC - PHYSICAL RELOCATION OF FLOW DIVIDERS AND JUNCTION BLOCKS

To simplify the hydraulic module to lift piping, the two flow dividers and two junction blocks have been moved to the lift pod as shown schematically in Figure 4-5. This change halves the number of lines from the hydraulic module to

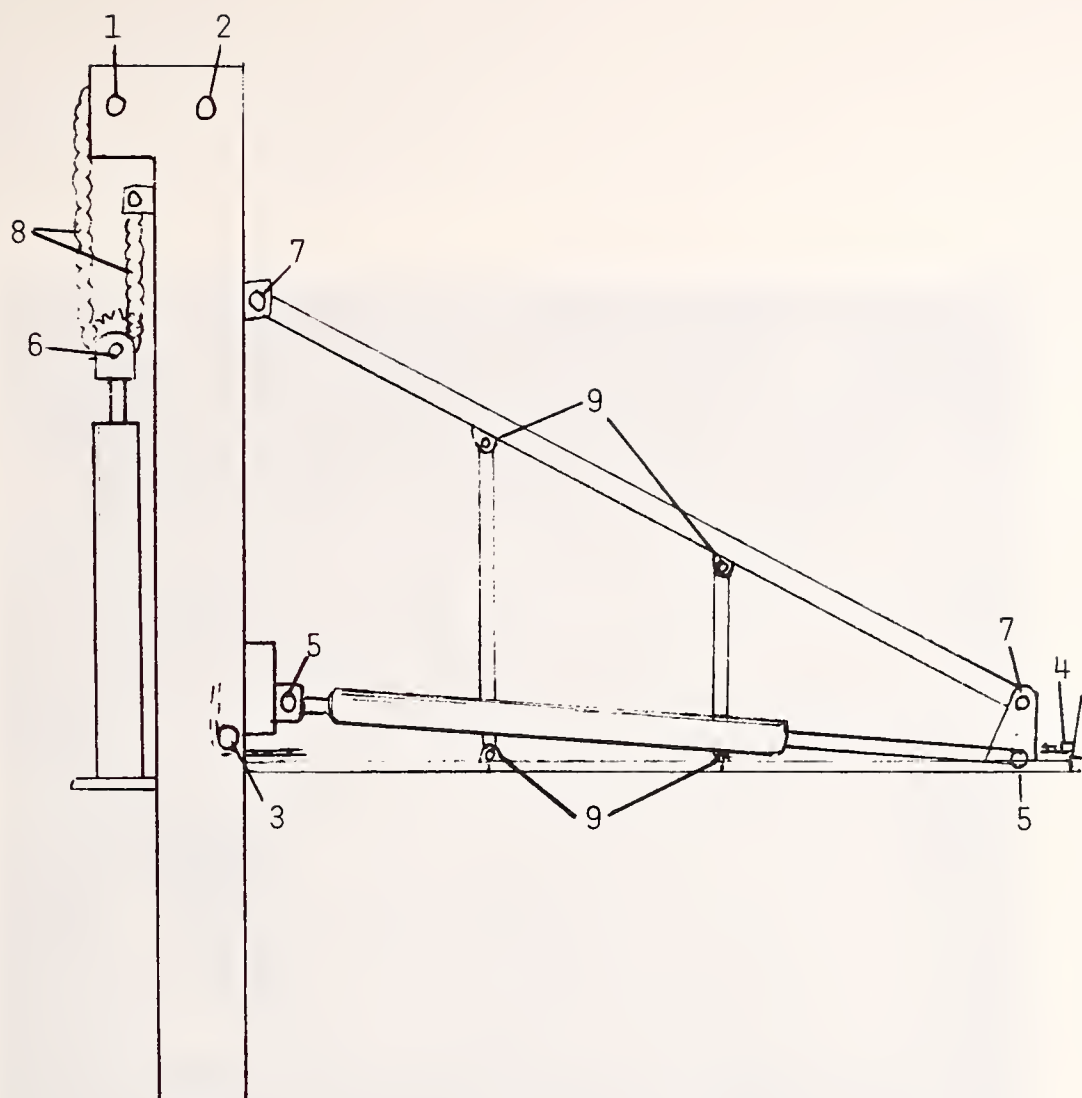
FIGURE 5-1. RESULTS OF COMPONENT FAILURE TESTS

<u>Item</u>	<u>Component</u>	<u>Failure Load</u>
1	Lift chain idler sprocket pin and bearing	9,400 lb.
2	Inner column upper pulley pin	8,400 "
3	Safety gate cable pulley pin	3,210 "
4	Safety gate cable end assembly	4,100 "
5	Platform cylinder clevis yoke pin	7,200 "
6	Lift cylinder sprocket pin	9,700 "
7	Platform radius arm pin	6,820 "
8	Lift chain assembly	3,260 "
9	Platform support stringer pins	3,140 "

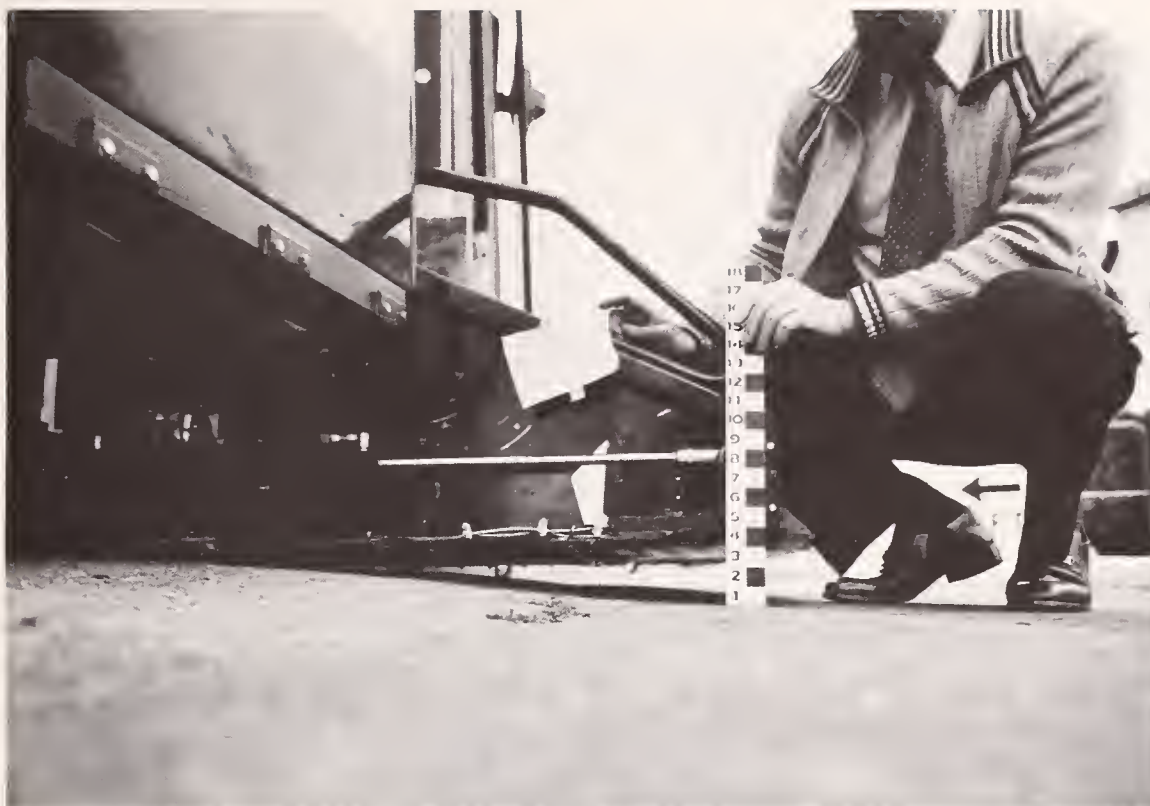
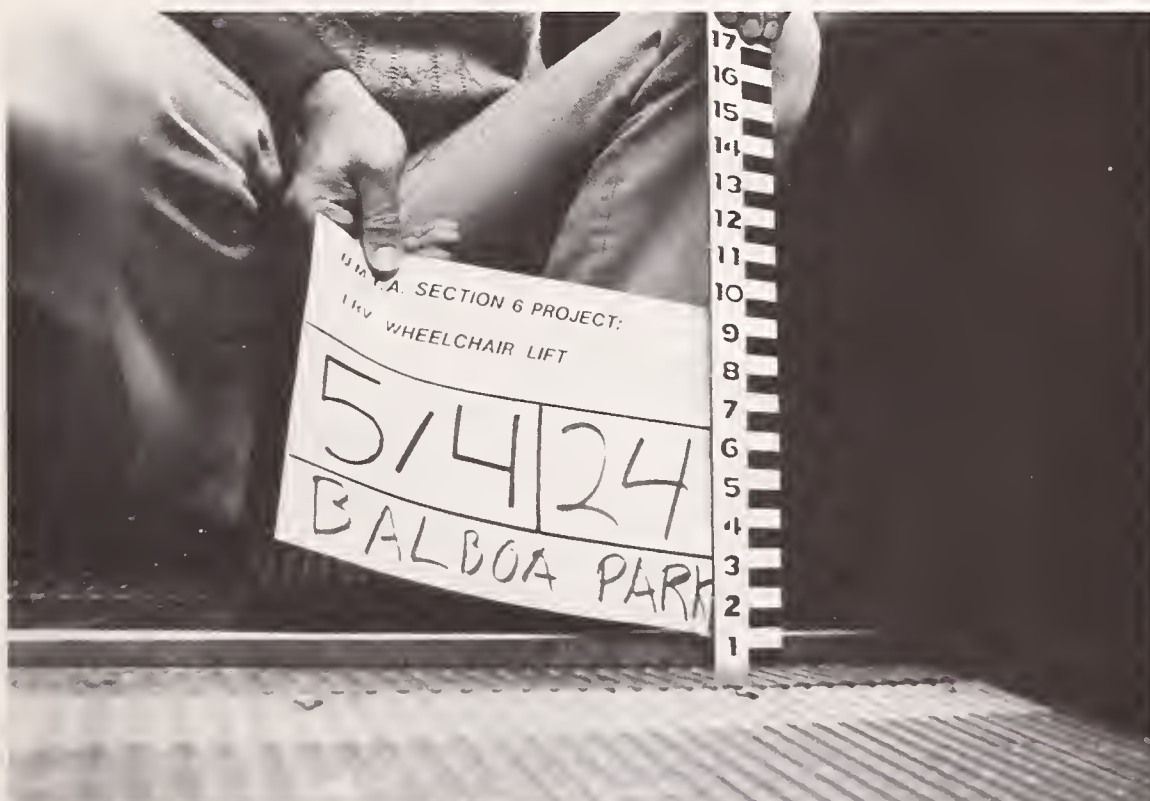
FIGURE D1-9. IMPACT OF EXCESSIVE STREET CROWN (TOP) INSTANCE OF RAISED PLATFORM UNDER LOAD NOT FLUSH WITH LRV FLOOR (BOTTOM)

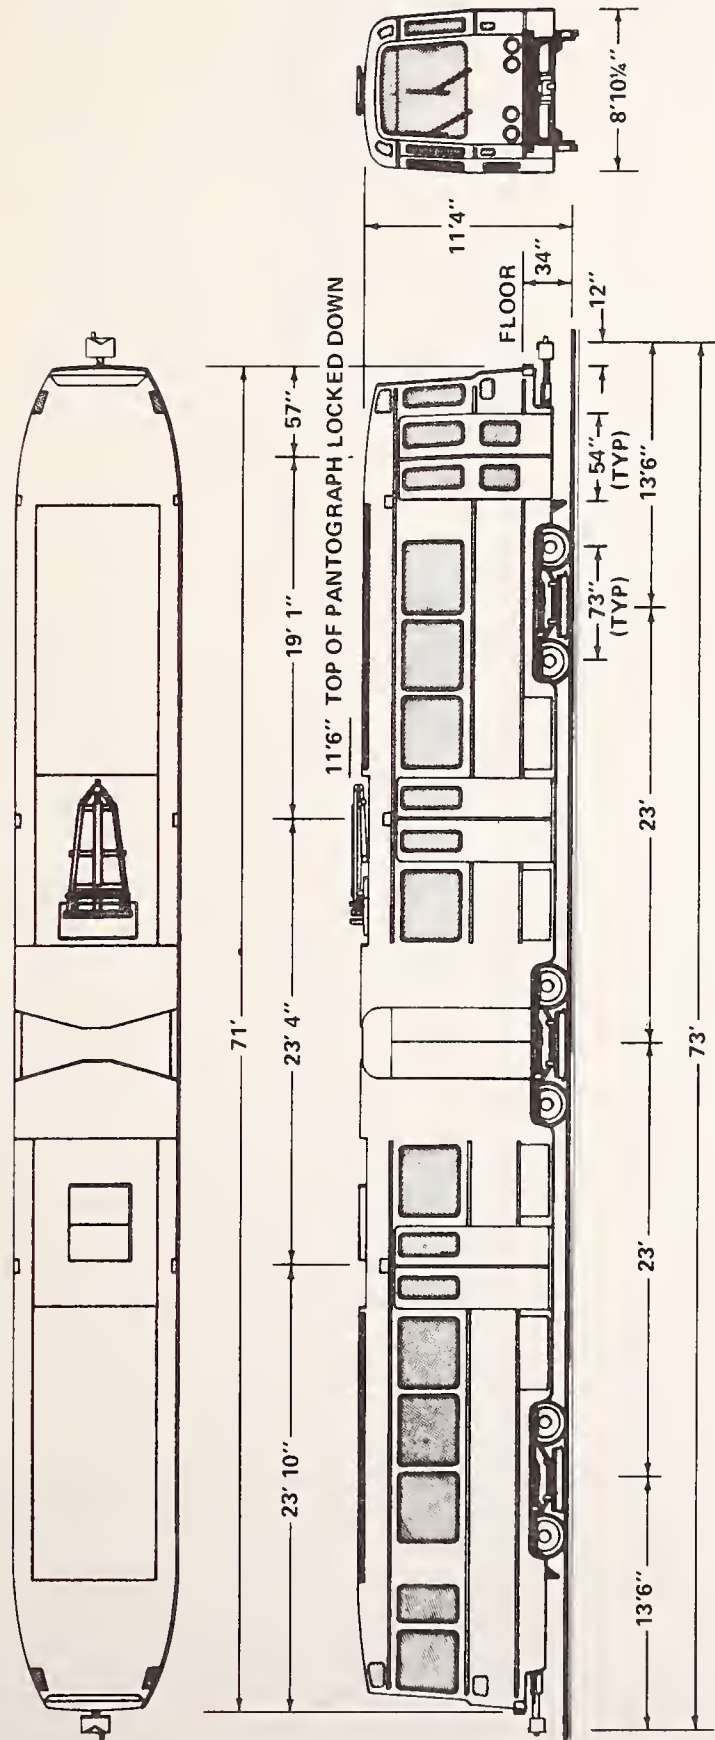
FIGURE D3-1. DESIGN AND OPERATING CHARACTERISTICS

Length, over anticlimbers	71 ft	Acceleration, maximum	2.8 mph/sec \pm 10%
Height, from top of rail	11 ft 4 in.	Brake rate	3.5 mph/sec
Width, maximum	8 ft 10 1/4 in.	Service, nominal	6.0 mph/sec (below 30 mph)
Weight empty	67,000 lb	Emergency, minimum	4.0 mph/sec (above 30 mph)
Passenger capacity		Jerk rate, nominal	2.5 mph/sec/sec
Seats - MBTA	52	Wheel diameter	26 in.
Seats - San Francisco	68	Power, nominal	600 volts D.C.
Maximum capacity	219	Noise levels	65 dBA
Track gauge	4 ft 8 1/2 in. (Std)	Interior, all systems operating	80 dBA
Track radius, minimum, horiz.	32 ft	Wayside 50 ft at 40 mph	
Speed, maximum operating	50 mph
